ANNUAL REPORT FOR 2012

**UT to Forney Creek
Lincoln County
TIP No. R-2206B
COE Action ID: 200431320
DWQ WQC #: 3476**

Prepared By:
Roadside Environmental Unit & Natural Environment Unit
North Carolina Department of Transportation
March 2012

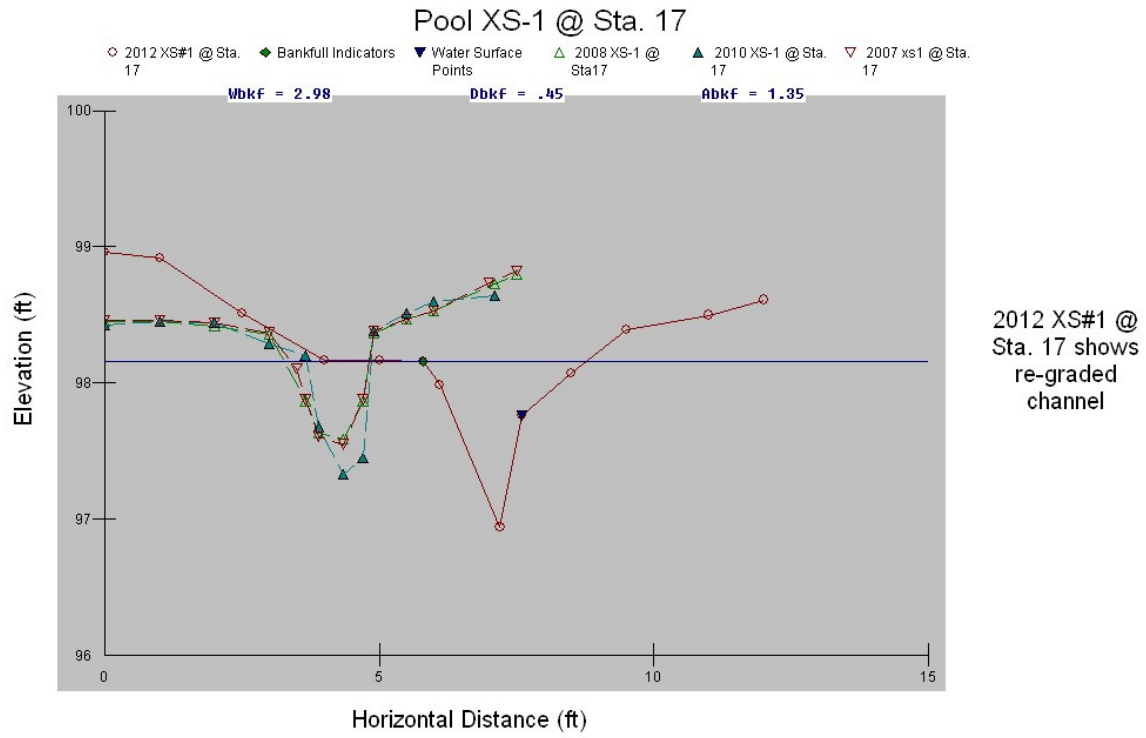
2007	2008	2010	2012
Bankfull Width (m)	1.9	1.9	3.43	2.98
Bankfull Mean Depth (m)	0.46	0.48	0.35	0.45
Width/Depth Ratio	4.13	3.96	9.8	6.62
Bankfull Cross Sectional Area (m²)	0.87	0.92	1.19	1.35
Maximum Bankfull Depth (m)	0.82	0.77	1.11	1.22
Width of the Floodprone Area (m)	7.5	7.5	7.1	12
Entrenchment Ratio	3.95	3.96	2.07	4.03

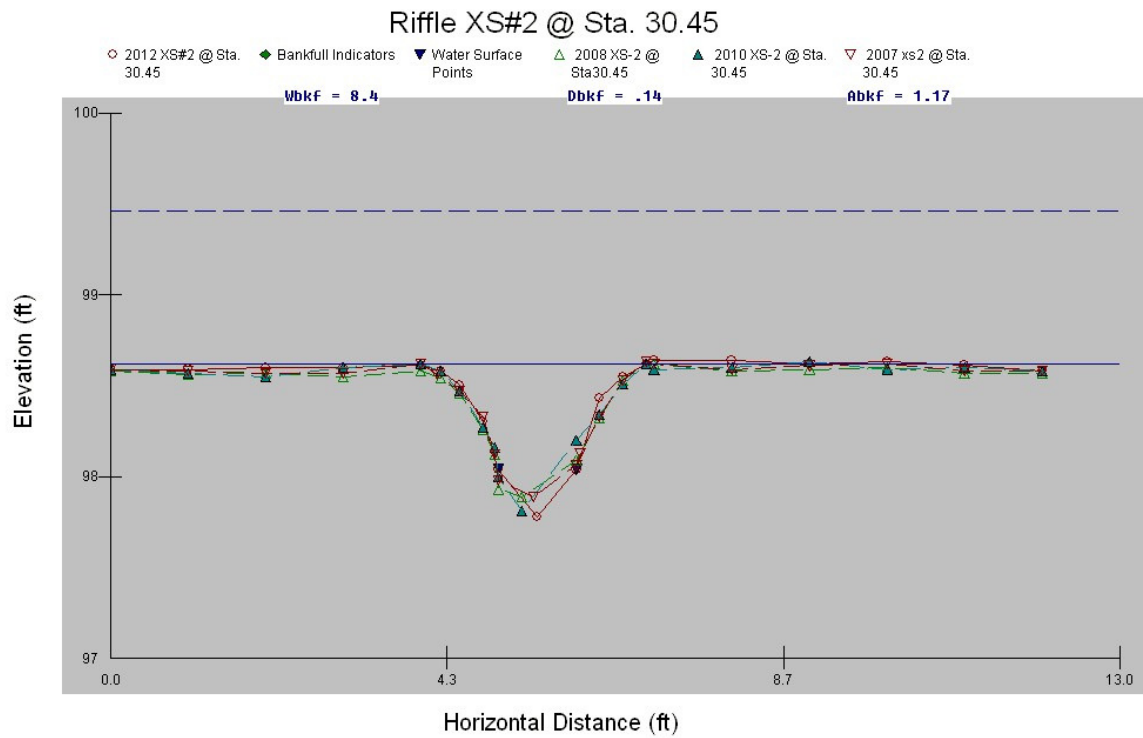
2007	2008	2010	2012
Bankfull Width (m)	2.87	2.77	2.9	2.9
Bankfull Mean Depth (m)	0.36	0.34	0.35	0.36
Width/Depth Ratio	7.97	8.15	8.29	8.06
Bankfull Cross Sectional Area (m²)	1.05	0.95	1.02	1.06
Maximum Bankfull Depth (m)	0.73	0.69	0.81	0.84
Width of the Floodprone Area (m)	12	12	12	12
Entrenchment Ratio	4.18	4.34	4.14	4.14

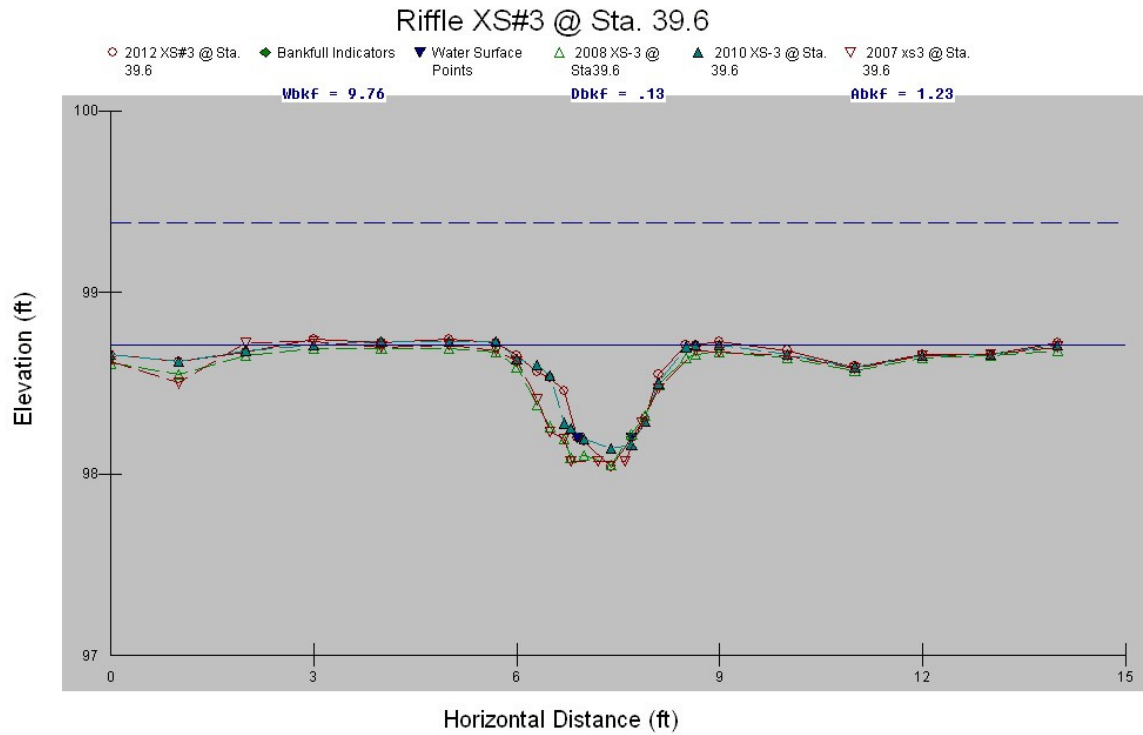
2007	2008	2010	2012
Bankfull Width (m)	2.95	2.76	2.89	2.76
Bankfull Mean Depth (m)	0.35	0.13	0.3	0.3
Width/Depth Ratio	0.61	8.12	9.63	9.2
Bankfull Cross Sectional Area (m²)	1.03	1.22	0.86	0.84
Maximum Bankfull Depth (m)	0.61	0.61	0.57	0.67
Width of the Floodprone Area (m)	14	14	14	14
Entrenchment Ratio	4.75	5.07	4.84	5.08

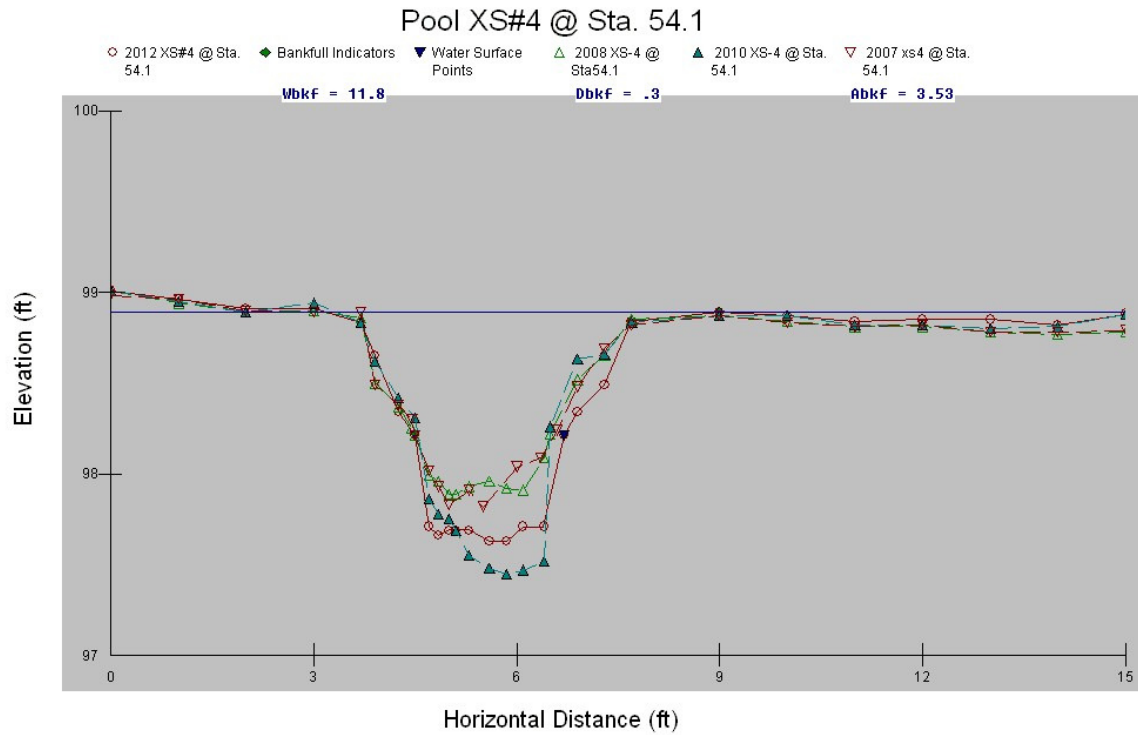
Cross-Section #4 (Pool) Abbreviated Morphological Summary*				
	2007	2008	2010	2012
Bankfull Cross Sectional Area (m ²)	2.3	2.51	3.08	3.3
Maximum Bankfull Depth (m)	1	0.98	1.42	1.26
Bankfull Mean Depth (m)	0.58	0.47	0.58	0.57
Bankfull Width (m)	3.96	5.3	5.3	5.83

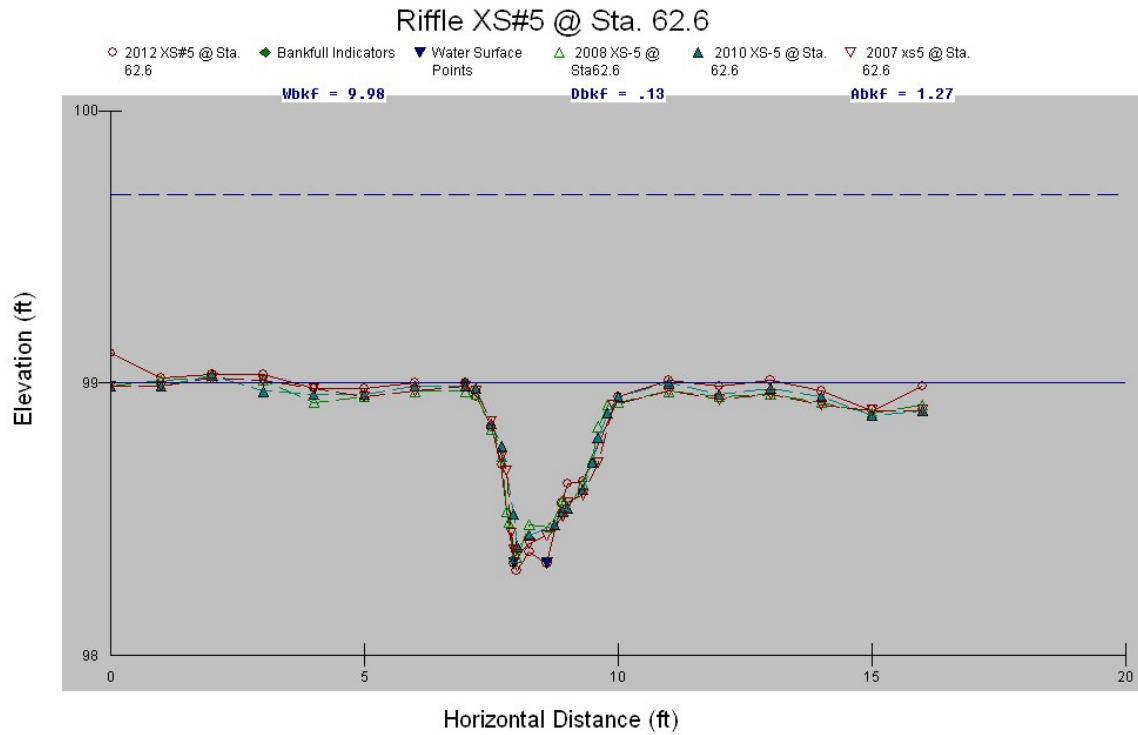
2007	2008	2010	2012
Bankfull Width (m)	2.55	2.6	2.8	3.83
Bankfull Mean Depth (m)	0.33	0.35	0.34	0.29
Width/Depth Ratio	7.73	7.43	8.24	13.21
Bankfull Cross Sectional Area (m²)	0.83	0.9	0.95	1.1
Maximum Bankfull Depth (m)	0.55	0.61	0.59	0.69
Width of the Floodprone Area (m)	16	16	16	16
Entrenchment Ratio	6.27	6.15	5.71	4.17

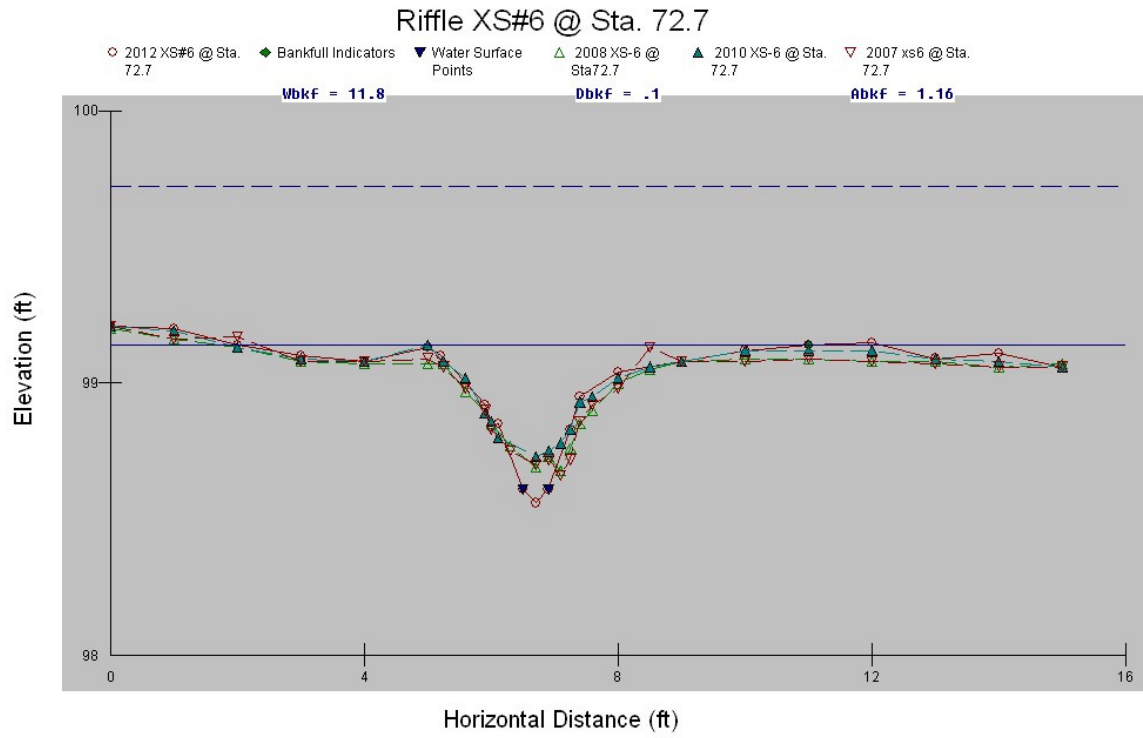
2007	2008	2010	2012
Bankfull Width (m)	3.34	3.58	4.92	4.93
Bankfull Mean Depth (m)	0.21	0.18	0.15	0.17
Width/Depth Ratio	15.9	19.89	32.8	29
Bankfull Cross Sectional Area (m²)	0.71	0.64	0.75	0.83
Maximum Bankfull Depth (m)	0.43	0.39	0.39	0.56
Width of the Floodprone Area (m)	15	15	15	15
Entrenchment Ratio	4.49	4.19	3.05	3.04

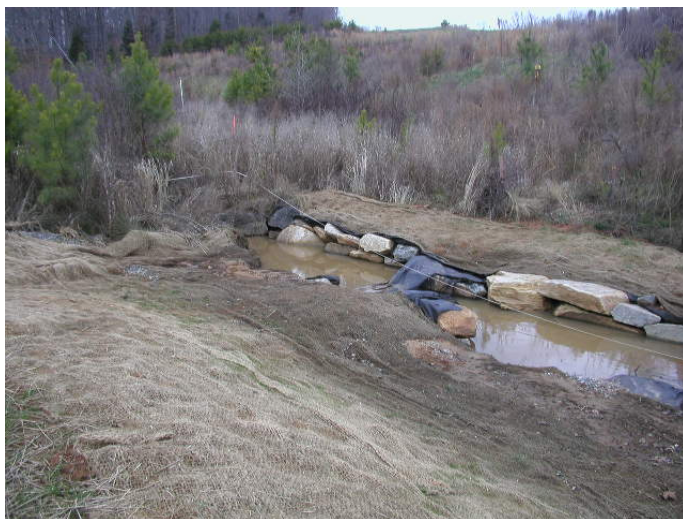
Based on comparisons of the five years of monitoring data, all six cross sections appear stable with little or no active bank erosion. Graphs of the cross sections are presented in Appendix A. Future survey data will vary depending on actual location of rod placement and alignment; however this information should remain similar in appearance. In late October/early November 2011, the eroded section of the channel near the culvert was repaired by shifting the alignment of the channel to the south onto the low bench that had formed. Two cross-vanes were installed for grade control due to the elevation difference between the upstream existing cross-vane and the culvert invert. Boulder toe protection was used on the left hand bank (looking downstream) to help stabilize the bank. A previously noted crossvane just upstream of Photo Point #3 that had water piping under the structure and a slight headcut had formed was also repaired with hand tools. The repaired area was replanted with live stakes and bareroot seedlings in February 2012.

Repaired area at Cross Section #1
January 2012

Site Notes: Planted vegetation was dormant at the time of monitoring. The lower end that was reconstructed was replanted with live stakes and bareroot seedlings in February 2012.

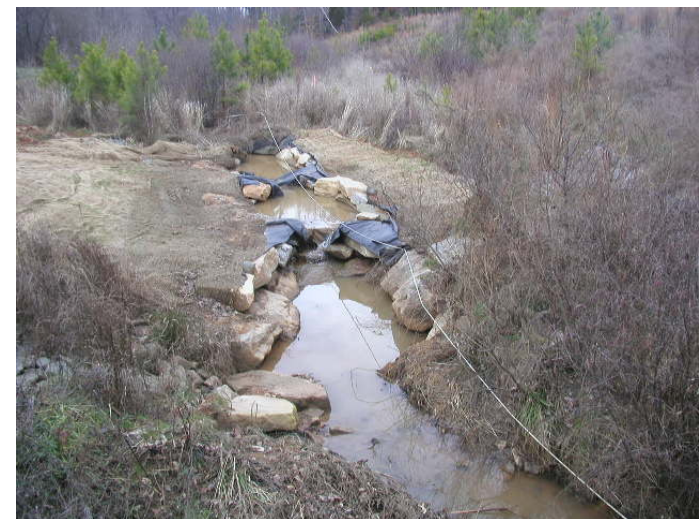
Looking upstream at repaired area at Cross Section#1
